A study of the microstructural basis for the strength and toughness properties of as-quenched and quenched and tempered high copper HSLA-100 steel

A STUDY OF THE MICROSTRUCTURAL BASIS FOR THE
STRENGTH AND TOUGHNESS PROPERTIES OF
AS-QUENCHED AND QUENCHED AND TEMPERED HIGH
COPPER HSLA-100 STEEL

DECEMBER 1991

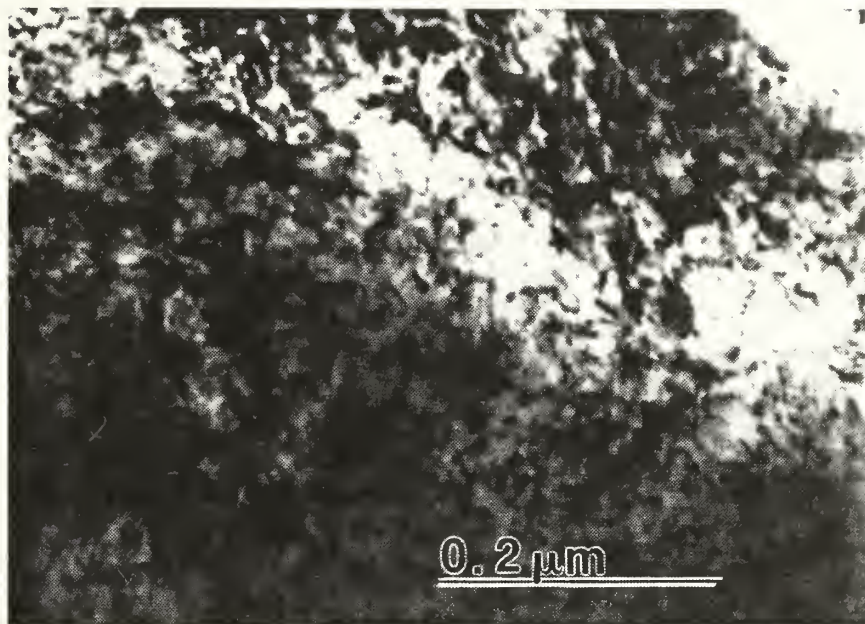
Figure 18 TEM Image Showing Carbide Precipitates

Figures 16 and 17 are TEM micrographs showing the general microstructure of lath martensite. Figure 18 and 19 are TEM micrographs showing autotemper Fe_3C carbides and the

high dislocation density. These were expected for this low carbon, high martensite start temperature steel. Retained austenite is observed in the bright field micrograph of Figure 20. In the dark field micrograph of Figure 21, the retained austenite is illuminated. Copper precipitates were not evident as previously reported by Mohr [Ref. 2:p. 35] and this can be seen by Figures 22, 23 and 24. There is no evidence of streaking as the selected area diffraction patterns (SADP) show. It had been reported by Howell that copper precipitates can be present on quenching, but the specimens he used were oil-quenched, allowing a slower cooling rate [Ref. 42:p 902].

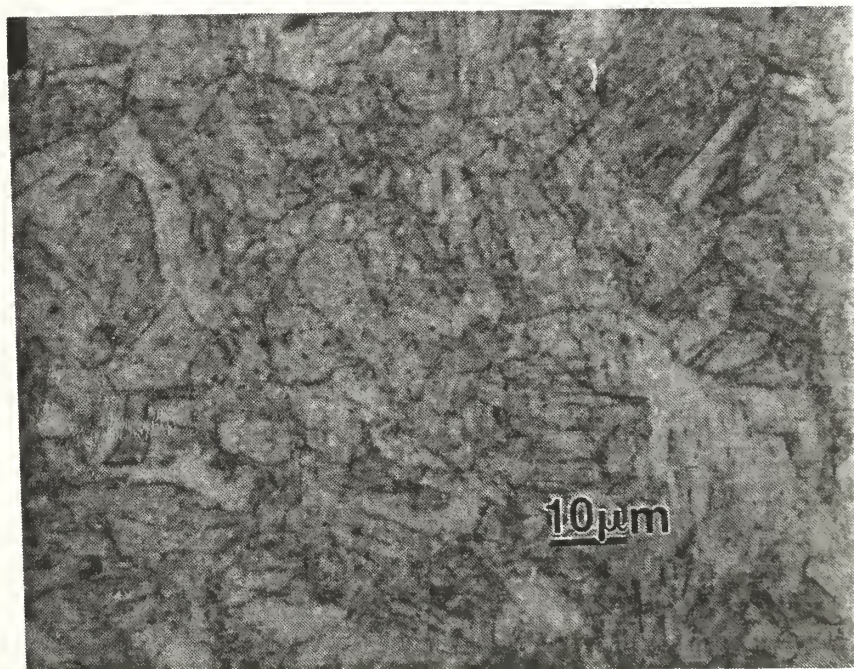
Figure 35 Optical Micrograph of 621°C Aged High Copper HSLA-100 Steel Showing the Increased Transformation Product Packet Size

Figures 35 and 36 show the overaged microstructure of high copper HSLA-100 steel. The transformation product packet size is approximately 10 μm and the lath width has widened considerably from the as-quenched condition. This increased lath width can be seen in Figure 37. Incoherent ϵ -copper precipitates are now visible having replaced the coherent BCC
